Energy Performance Audit Report

Year Built: 1870 **Age of Dwelling:** 138 Years **Square Footage of Home:** 2,400
Primary Foundation type: Crawlspace **Primary Heating Fuel type:** Propane
Date of Inspection: 4/16/08 **Time Scheduled:** 9:00 **Report Number:** 20
Weather Conditions: Partly sunny & cool **Temperature:** Upper 40's to start
House Is Facing: South

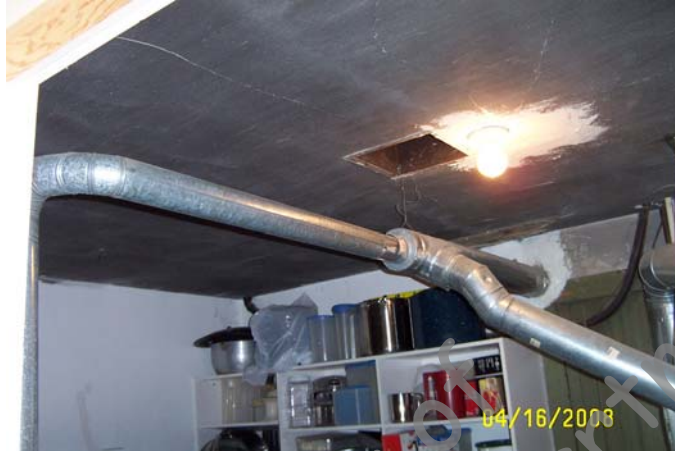
Comments: The slope of the attic furnace flue pipe should be more positive to help ensure adequate draft.

The flue pipe slope for both the water heater and attic furnace should be increased.
